SERVICE BULLETIN

Inspection and/or replacement of the valve push-rod assy., rocker arm left and rocker arm right for ROTAX® Engine Type 912 i, 912 and 914 (Series)

ATA System: 72-30-00 Cylinder head

MANDATORY

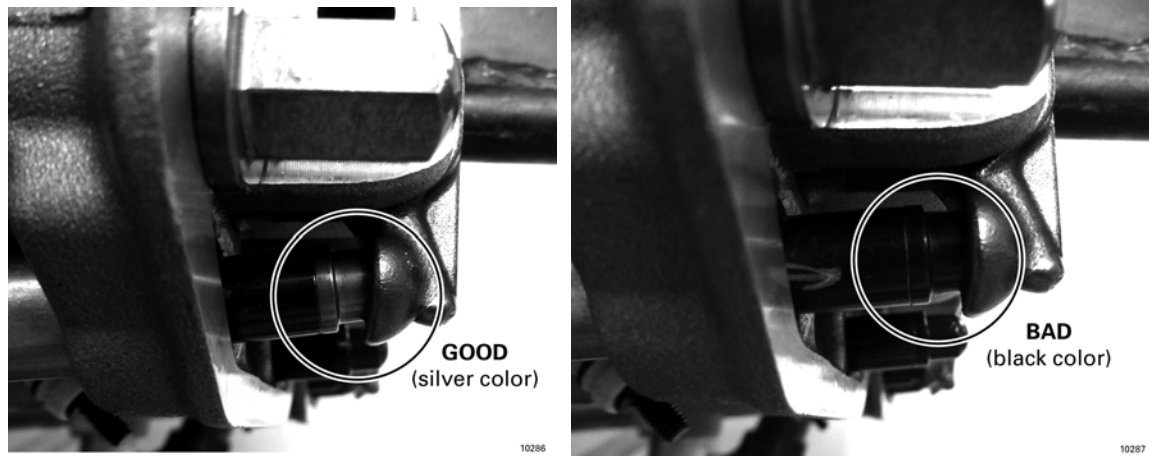
Fig. 1
Visual inspection

Due to deviations in the manufacturing process of the valve push-rod assy., partial wear on the rocker arm ball socket may occur. This wear might lead to a rocker arm cracking / fracture which in consequence may lead to a malfunction of the valve train. Possible effects are rough engine running or an unusual engine operating behaviour.

Perform visual inspection of all push-rod ball sockets on all cylinder.
 Check for color. See Fig. 1.

Color	Evaluation
Silver surface	Valve push-rod is OK. No further action required for this valve push-rod.
Black surface	Valve push-rod is NOT OK. See section. 3.1.3) Replacement of affected parts.

GOOD
(silver color)

BAD
(black color)

3.1.3) Replacement of affected parts on affected cylinder positions (only in case visual inspection is NOT passed OK)
